INDOOR AIR QUALITY REASSESSMENT

**Lynch Elementary School
19 Brantwood Road
Winchester, Massachusetts**

Prepared by:
Massachusetts Department of Public Health
Bureau of Environmental Health Assessment
July, 2001

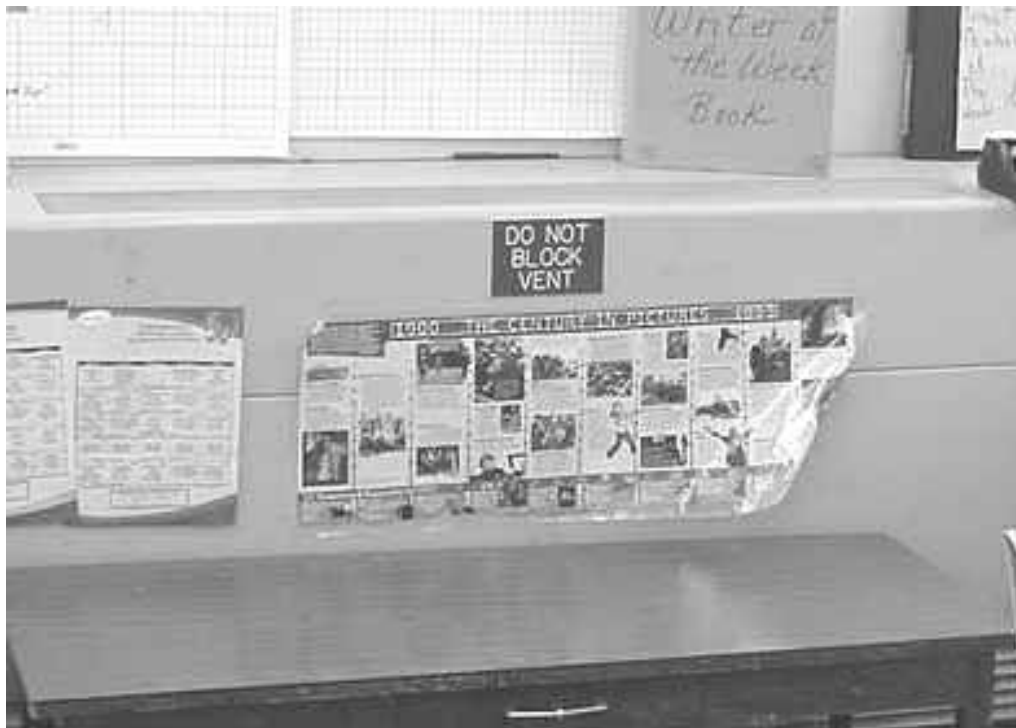
Picture 1

Staff were instructed via inter-school memorandum to remove materials obstructing airflow of univents and exhaust vents. In addition, placards were posted on univents to remind faculty to keep units free from clutter (see Picture 1). Adherence to this instruction was seen in most classrooms.

Placard on Classroom Univent

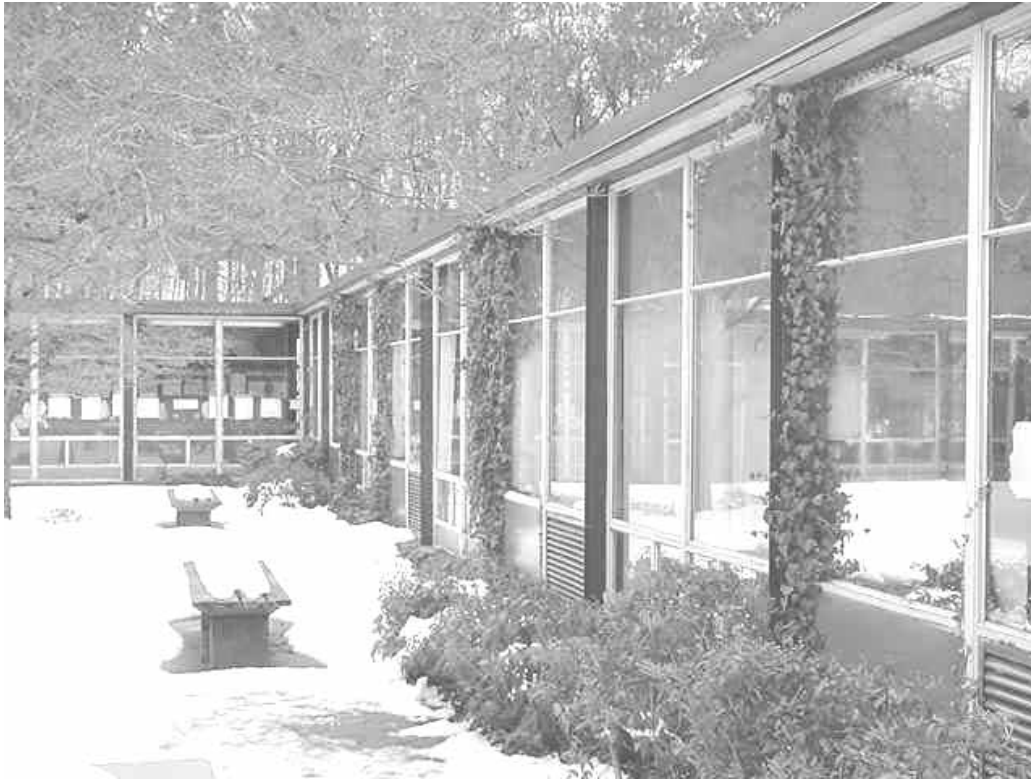
Picture 2

Plants continue to be in direct contact with exterior walls (see Pictures 2 & 3) and is further addressed in the "Microbial/Moisture Concerns" section later in this report.

The courtyard walls of the school remain covered with ivy in a number of areas (see Picture 2). As discussed in the previous report, clinging plants can cause water damage to brickwork by inserting tendrils into brick and mortar. Water can penetrate into the brick along the tendrils, which can subsequently freeze and thaw during the winter. This freezing/thawing action can weaken bricks and mortar, resulting in damage to the wall. In order to avoid this problem, clinging plants on brickwork is not recommended.

Vine Growth on Exterior Walls of Courtyard

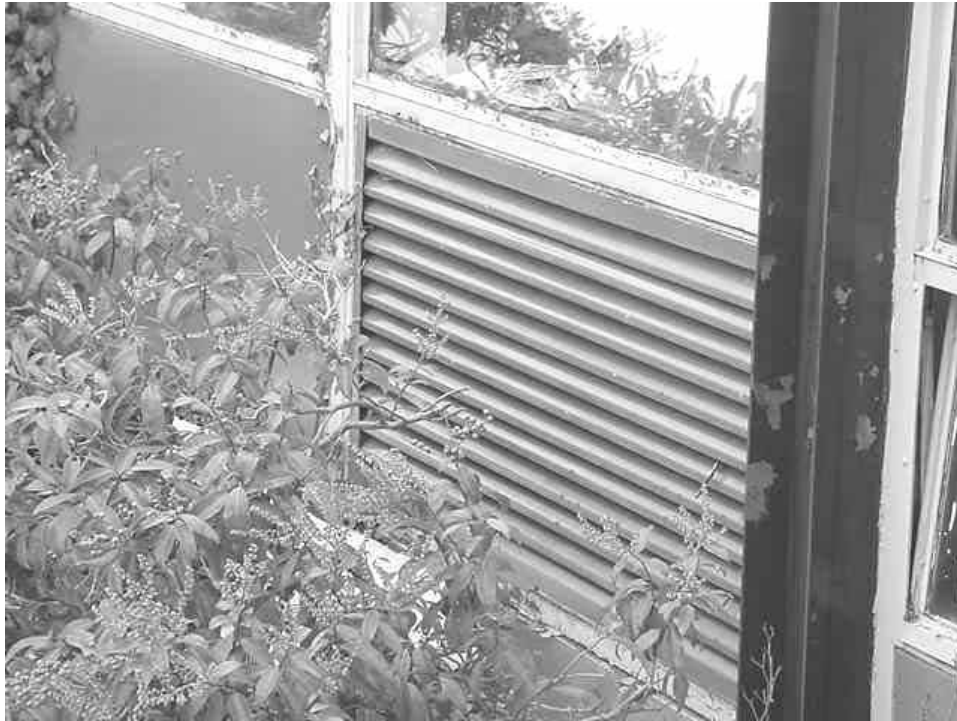
Picture 3

Along the perimeter of the building, shrubbery and flowering plants were noted in close proximity to univent fresh air intakes (see Picture 3). The March 15th visit occurred after a period of heavy snowfall. Along the perimeter of the building, univent fresh air intakes were noted partially covered with snow (see Picture 7). Care should be taken to ensure that fresh air intakes remain clear of obstructions (e.g., snow, and shrubbery) to avoid the entrainment of dirt, moisture and/or pollen.

Plant Growth near Univent Fresh Air Intake

15. **Inspect plant growth outside perimeter of building periodically; trim plants away from fresh air intakes as needed.**

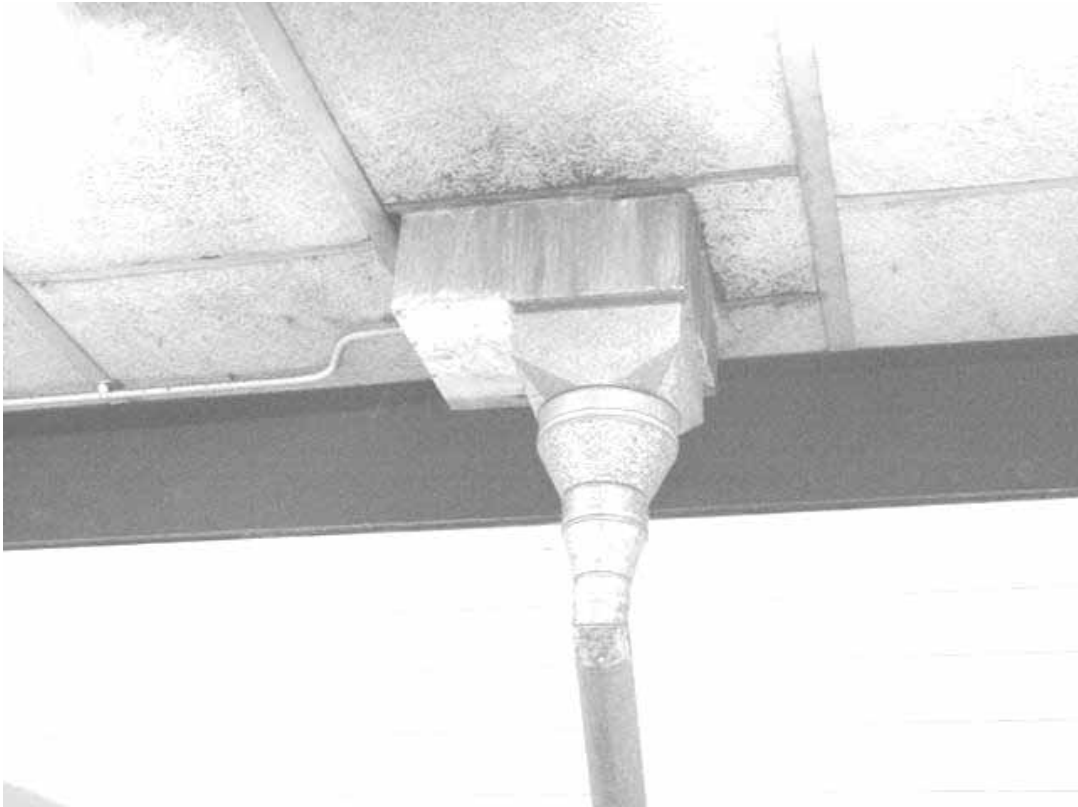
Picture 4

Ventilation for the kiln was reconfigured to provide local exhaust independent of the general exhaust (see Picture 4).

Reconfigured Local Exhaust for Kiln

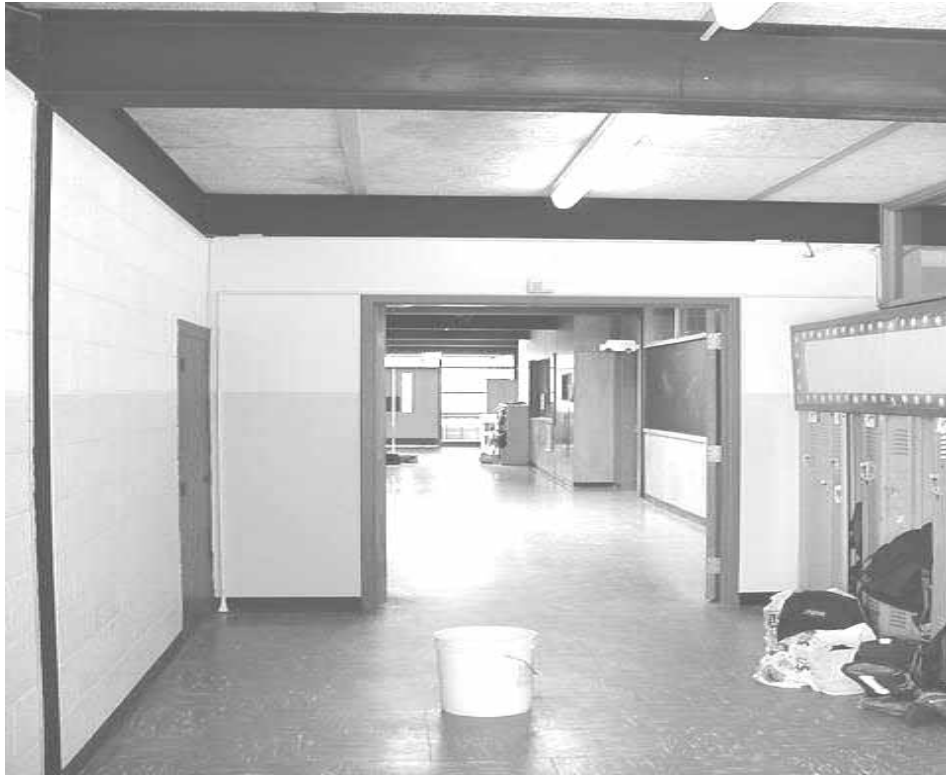
Picture 5

The school continues to experience problems with roof leakage. A number of areas still have water-stained ceiling panels, which are evidence of active or historic roof leaks. The BEHA reassessment occurred on a day following a period of heavy rain. A bucket was noted collecting water from an active leak in the hallway outside of classroom 112 (see Picture 5).

**Active Roof Leak in Hallway outside of Classroom 112
Note Bucket beneath Leak to Catch Water**

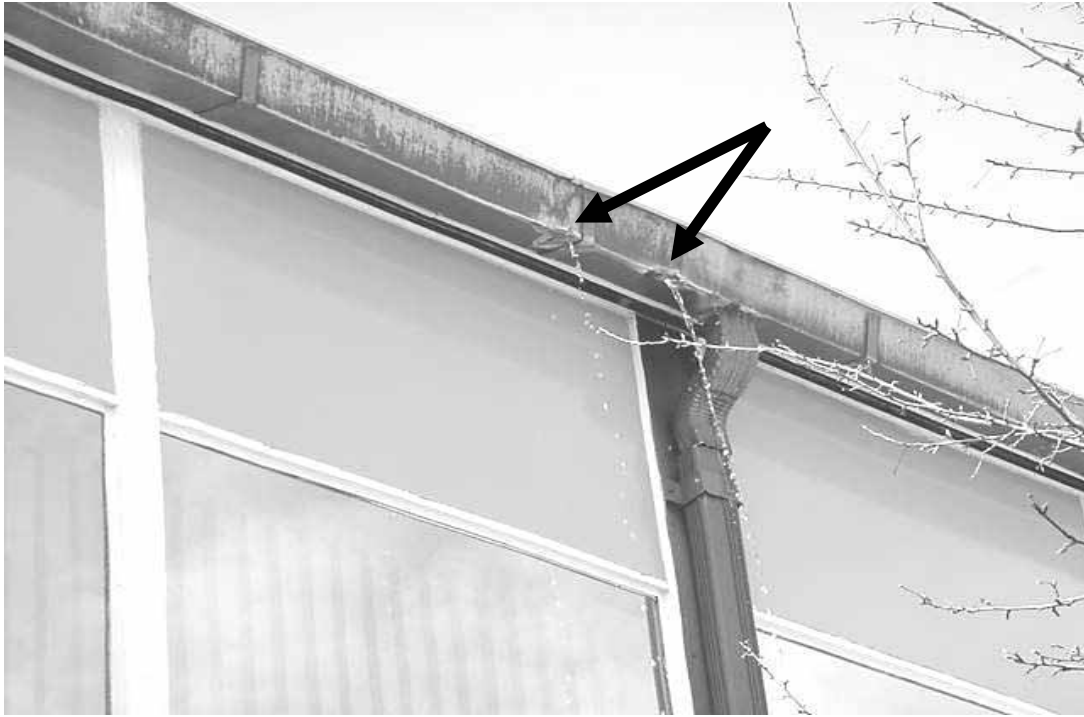
Picture 6

An inspection of the exterior of the school was conducted to identify possible sources of water entry. The building's roof drainage system collects water and directs it into a series of downspouts and/or drains. Along the front of the building holes were noted in the gutter system (see Picture 6), which can allow rainwater to pool on the ground at the base of the building against the exterior wall. The freezing and thawing action of water during the winter months can create cracks and fissures in the foundation. Over time, this process can undermine the integrity of the building envelope and provide a means of water entry into the building.

Water Leakage (Indicated by Arrows) through Holes in Gutter System

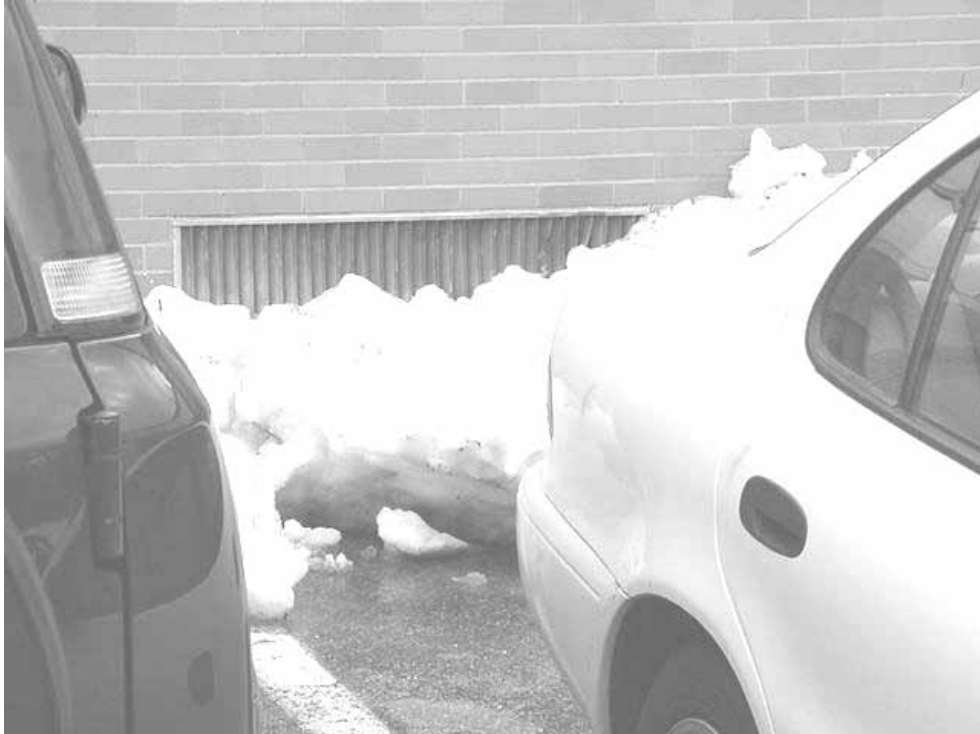
Picture 7

Univent Fresh Air Intake Obstructed with Snow, Also Note Vehicle Backed-into Parking Spot

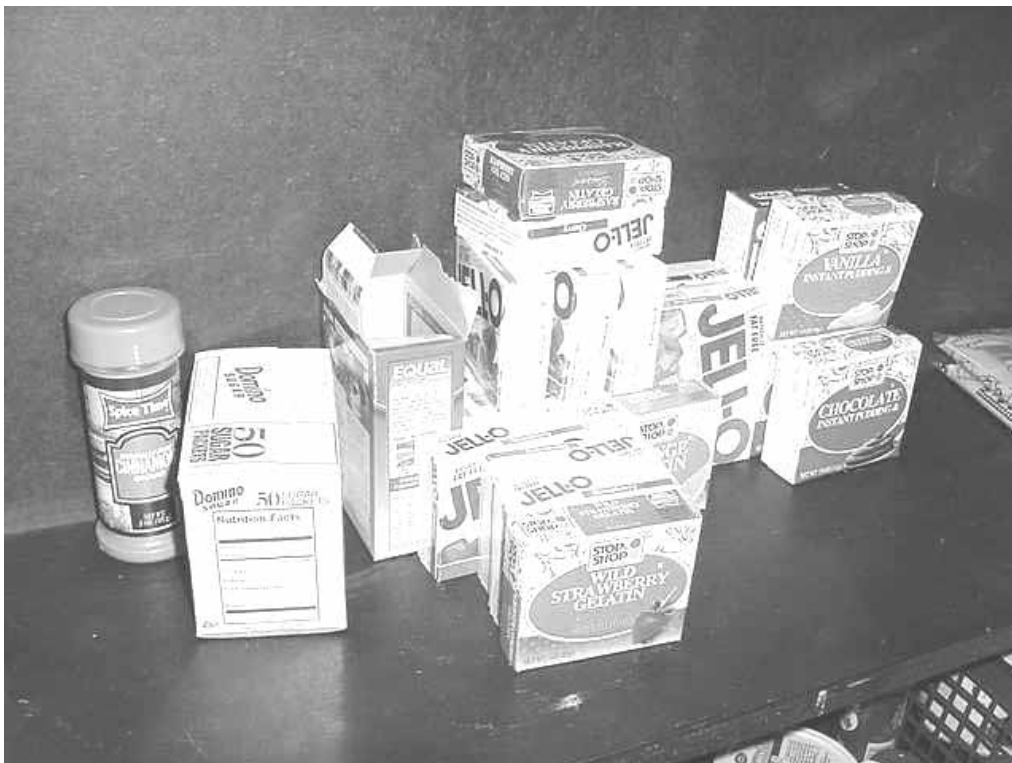
Picture 8

Foodstuffs Stored between Classrooms 100 & 110

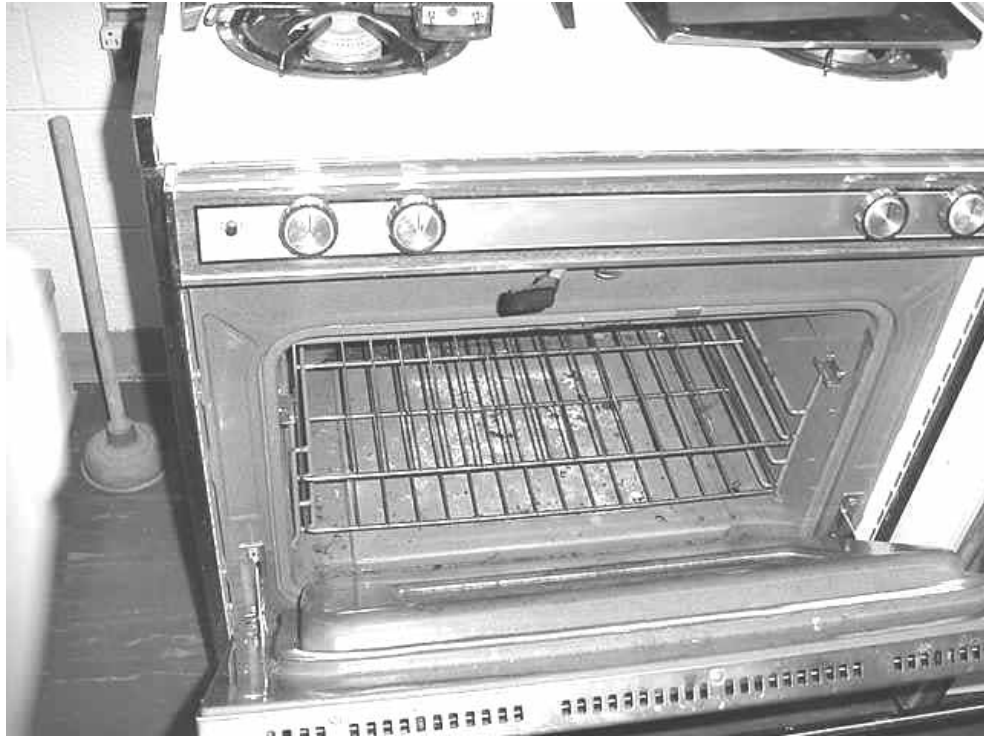
Picture 9

Food Debris/Crumbs in Oven between Classrooms 100 & 110

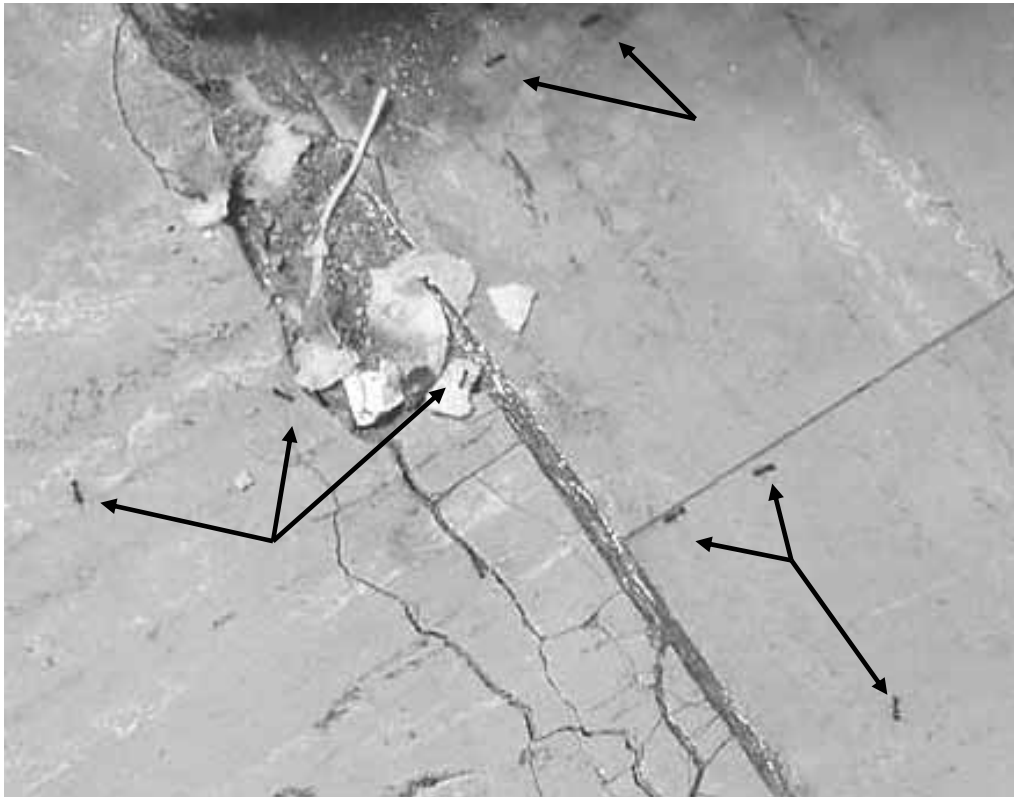
Picture 10

Several other conditions were noted during the assessment, which can affect indoor air quality. The building reportedly has a problem with pest infestation. Black ants were observed by BEHA staff in the storeroom between classrooms 100 and 110. A number of conditions were noted that can attract pests including the storage of foodstuffs, crumbs/food debris on the floor and in the oven (see Pictures 8-10). A spray can of insecticide was also noted in this area on top of the refrigerator (see Picture 11). Applicators of this product should be in full compliance with federal and state rules and regulations that govern pesticide use including posting and notification requirements (333

**Food Debris/Crumbs on Floor between Classrooms 100 & 110
Note Black Ants Indicated by Arrows**

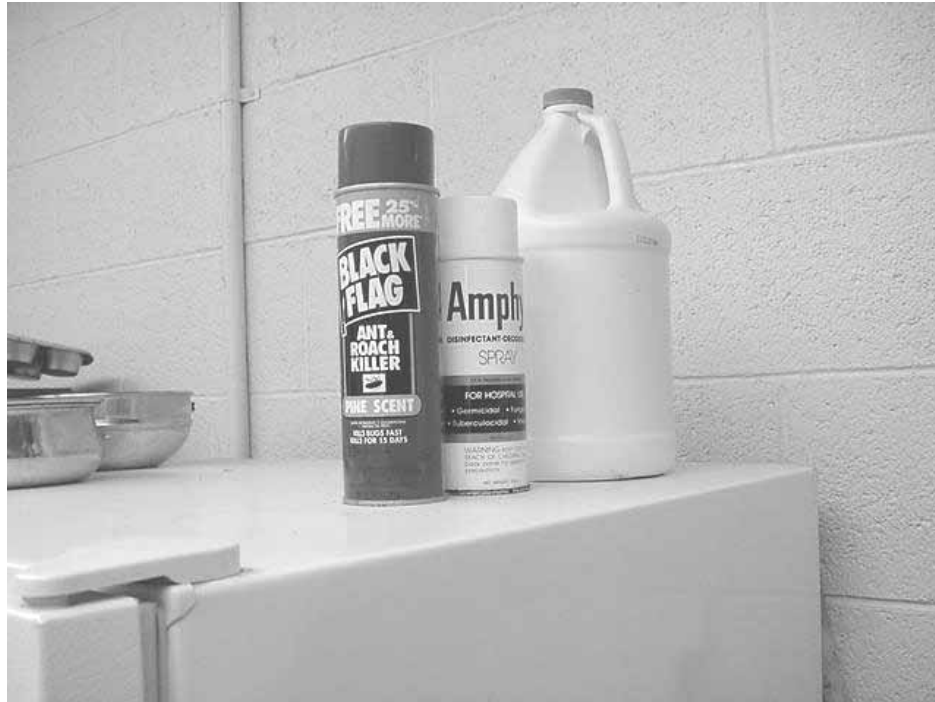
Picture 11

Insecticide on top of Refrigerator in Storeroom between Classrooms 100 & 110

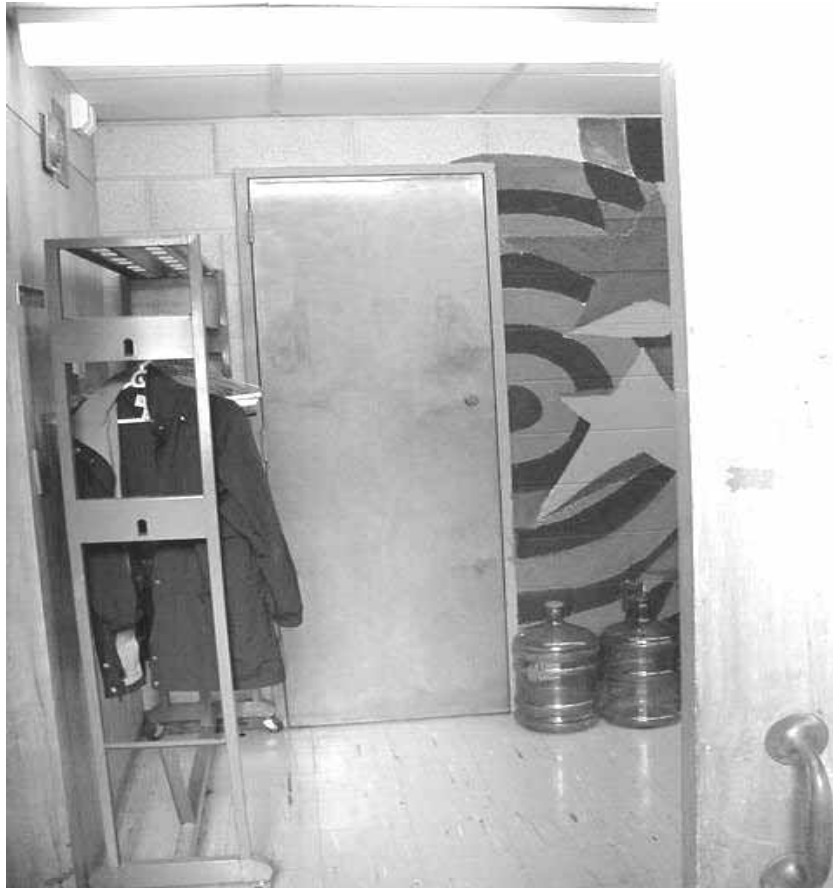
Picture 12

Occupants located in the basement/ground floor of the building complained of musty odors emanating from the crawlspace. BEHA staff noted spaces around the door

to this area (see Picture 12) that can serve as a means of egress for odors and drafts into occupied areas.

Crawlspace Door
